DEPARTMENT OF TRANSPORTATION

Contract #: 04-0120F4Cty: SF/ALA Rte: 80 PM: 13.2/13.9File #: 69.28**WELDING INSPECTION REPORT****Resident Engineer:**Pursell, Gary**Address:** 333 Burma Road**City:** Oakland, CA 94607**Report No:** WIR-012563**Date Inspected:** 25-Feb-2010**Project Name:** SAS Superstructure**OSM Arrival Time:** 700**Prime Contractor:** American Bridge/Fluor Enterprises, a JV**OSM Departure Time:** 1900**Contractor:** Zhenhua Port Machinery Company, Ltd (ZPMC), Changxing Island **Location:** Shanghai, China**CWI Name:** Du Zhi Qun**CWI Present:** Yes No**Inspected CWI report:** Yes No N/A**Rod Oven in Use:** Yes No N/A**Electrode to specification:** Yes No N/A**Weld Procedures Followed:** Yes No N/A**Qualified Welders:** Yes No N/A**Verified Joint Fit-up:** Yes No N/A**Approved Drawings:** Yes No N/A**Approved WPS:** Yes No N/A**Delayed / Cancelled:** Yes No N/A**Bridge No:** 34-0006**Component:** Tower**Summary of Items Observed:**

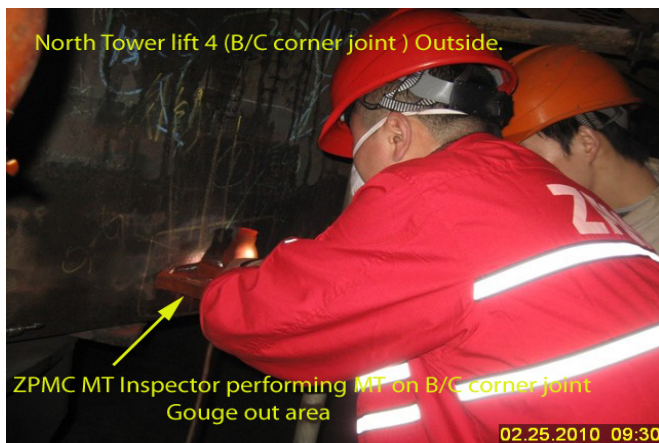
This QA Inspector observed during random Visual inspection, ZPMC Magnetic Particle Testing (MT) Inspector perform MT on North Tower lift 4 B/C corner joint gouge out area, MT performed at three locations. Joint identified as NSTL4-3B/L-5A. For more information see below attached photo.
